ZCFT-79-39-TJS/RJH  
NOVEMBER 1, 1979

PERFORMANCE OF ALUMINUM  
RIVETED CULVERT  
IN CALIFORNIA

PERFORMANCE OF ALUMINUM RIVETED CULVERT IN CALIFORNIA  
1978 COOPERATIVE CALTRANS-KAISER ALUMINUM SURVEY

T. J. Summerson and R. J. Hogan  
Applications Research

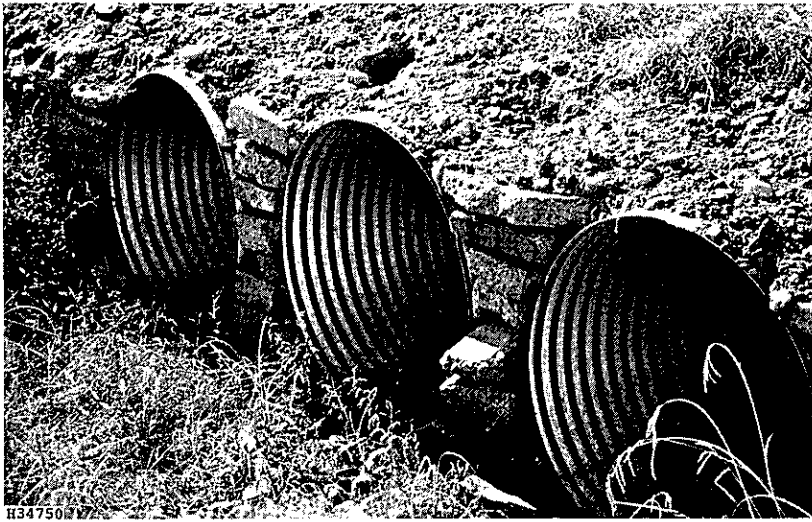
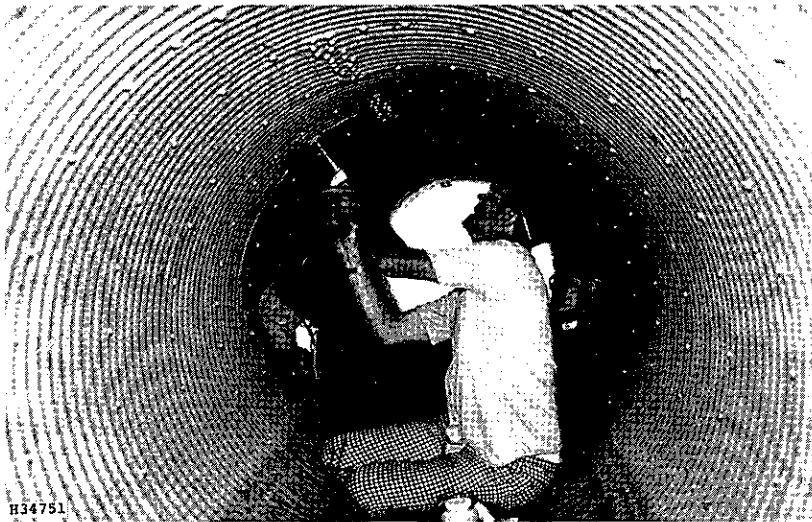
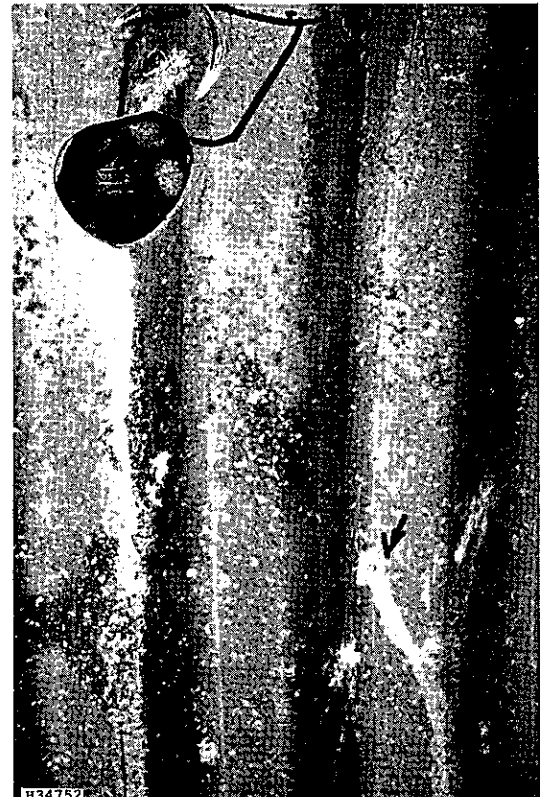
Figure 2

At Site 71-021, on Florin Road in Sacramento County, a few pinhole perforations were found in only one of the three pipes at this location. Ultrasonic thickness measurement survey showed the perforations were contained in a relatively small area in one or two 2-foot lengths of the one pipe. Nothing unusual was detected from the chemical analyses of the soil (71-021C in Tables II and III) taken from behind the metal sample with a perforation. As shown in Figure 2, the overall appearance and structural soundness of the culvert has been unaffected.

Site #71-021 - SACRAMENTO COUNTY - FLORIN RD.

Three 48-inch diameter, 12 gage Alclad 3004 pipes were installed in 1963. In 1978 (15 years), a few pinhole perforations were found in one two-foot section of one of the three pipes. The photo on the right shows where one pinhole perforation is marked by the black square and another pinhole is marked by black arrows. Ultrasonic thickness gage was used to determine extent of corrosion on soil side around these pinhole perforations. Full thickness was measured within 0.25 inches of each pinhole. The overall good appearance and condition of the pipe is indicated in the lower left photo, showing patch placement over the metal samples taken (see F21, 22 and 23).

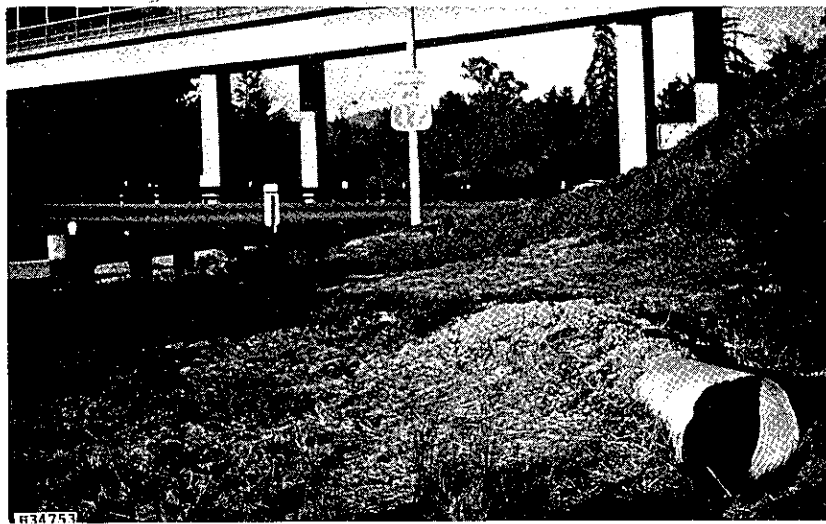
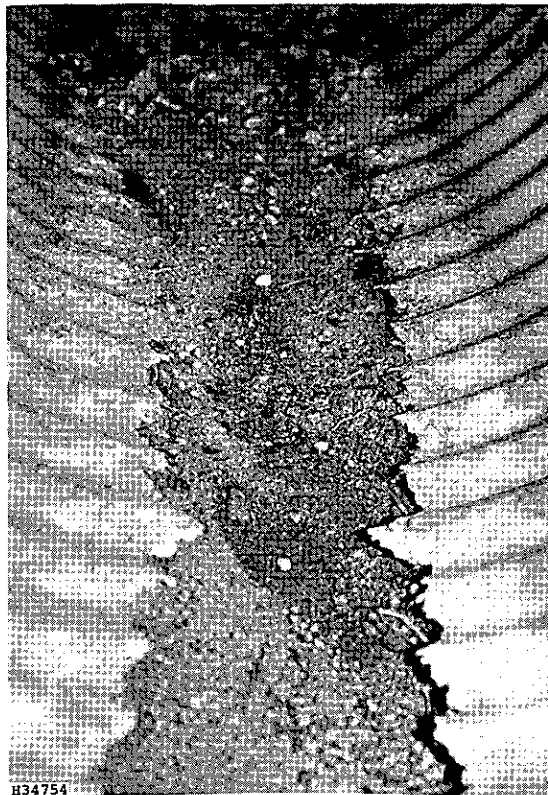
in less than one year. As Figure 3 shows, the pipe is still intact after 16 years, although the invert is completely corroded away. The explanation for corrosion in this instance appears to be related to the low pH (3.7-3.9) reported in 1978, as well as in the original 1965 report.

Site #78-28 - SANTA CRUZ - SCOTT'S CROSSING  
(IV-SCr-5-A)

In 1978, pH and minimum resistivity were measured as 3.8 and 5,000 ohm-cm. In 1964, they were reported as 3.7 and 330 ohm-cm.

In 1964, the invert was reported to have corroded through (perforated) in 0.83 years. (See Fig. 13 of Nordlin & Stratfull report.) In 1978, the invert (above) was found to be completely corroded through as the result of water side corrosion. However, soil side corrosion is still confined to the cladding thickness. See Figures F54 and F55 in this report.

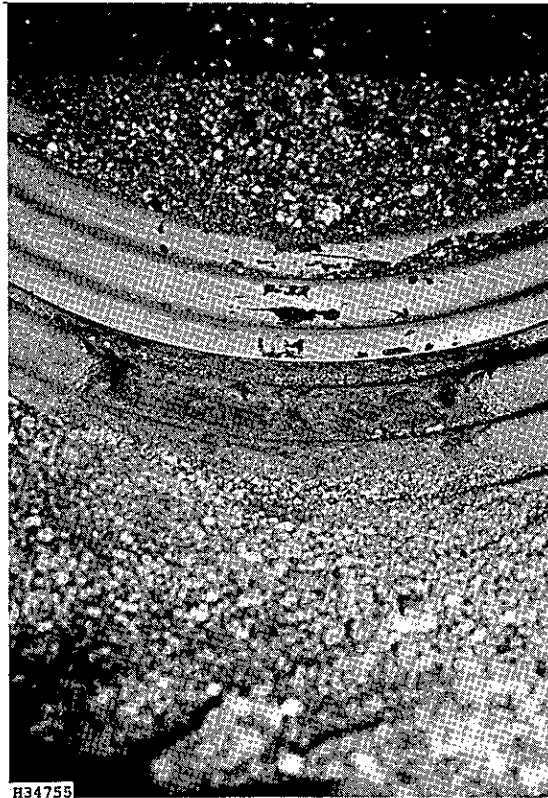
Site #67-126 - CALAVERAS COUNTY - HIGHWAY 4, EAST OF CAMP CONNELL

Installed in 1962 - 24 inch diameter, 14 gage pipe

Shown is the invert of aluminum pipe with an extension of galvanized steel pipe in foreground. The aluminum pipe was found to be in excellent condition, invert and soil sides. See Figure F33.

The galvanized steel pipe has begun to rust in the invert.

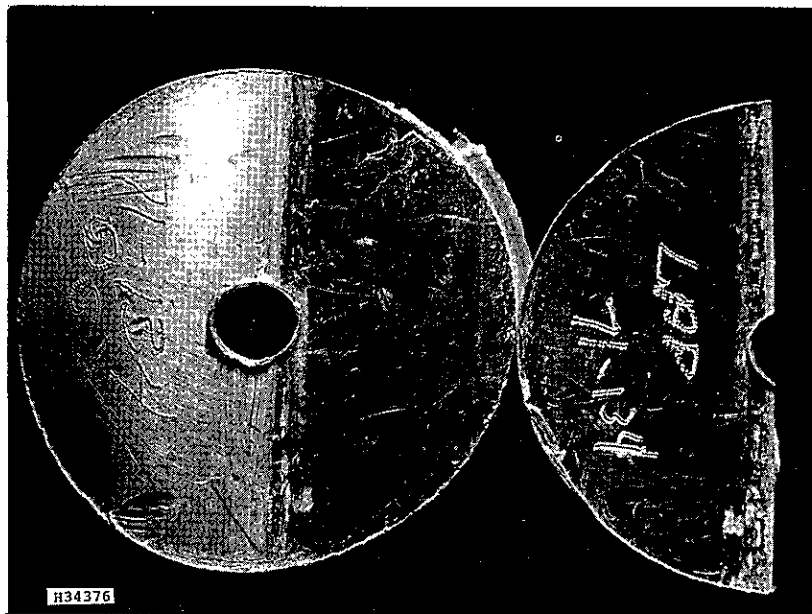
Crown-Lap, Interface

Lap Interface: No attack

Lap Interface  
1.5X, Cleaned ( $\text{CrO}_3/\text{H}_3\text{PO}_4$ )

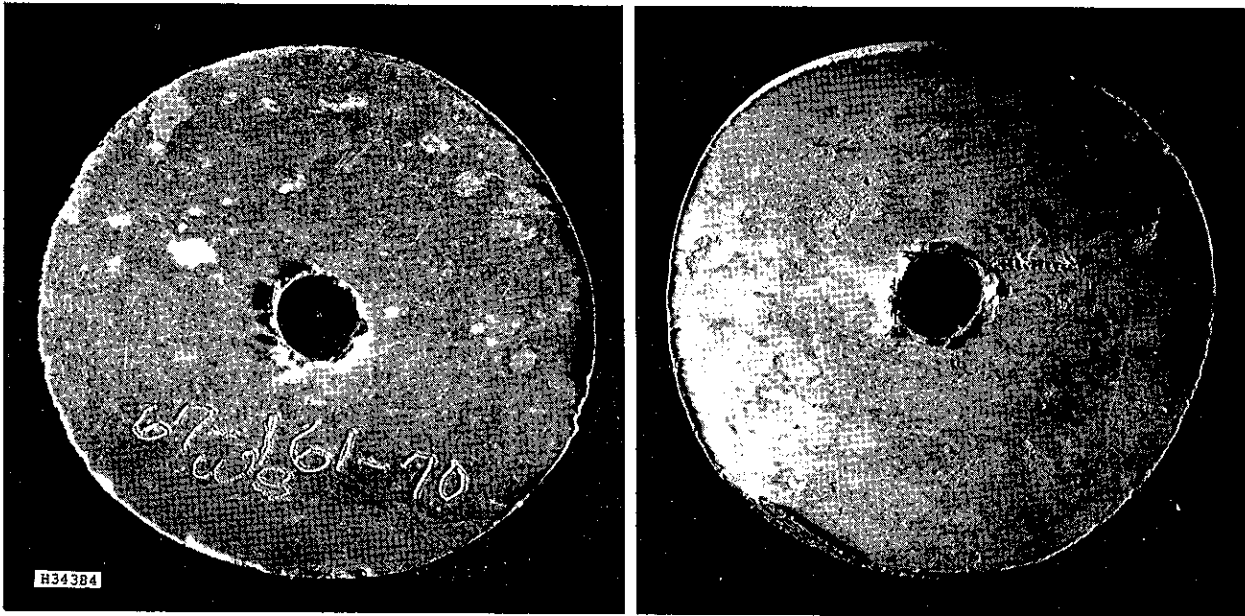
Crown  
From the Inlet End

Water Side: No attack

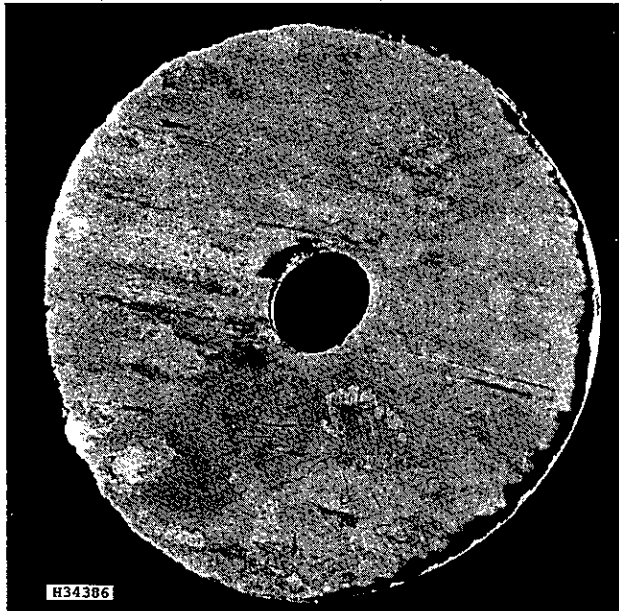
Crown  
From the Outlet End

Water Side: Light staining with several etched  
areas limited to the cladding  
surface

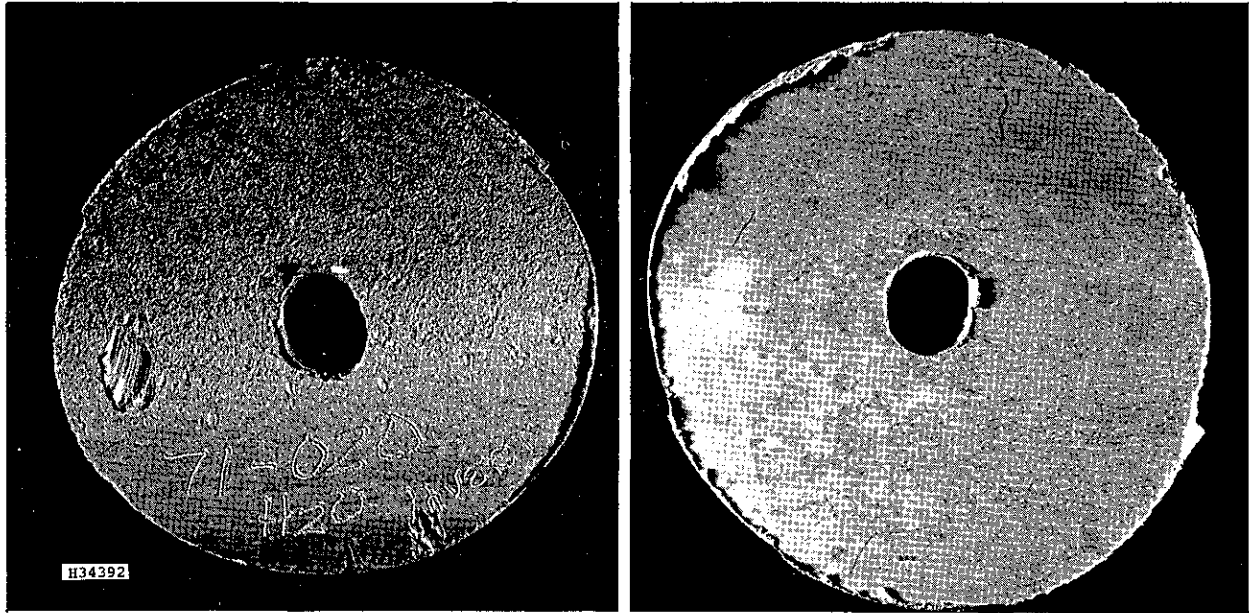
Invert  
8-Feet From Outlet End

Water Side: Water condensate staining,  
no corrosion

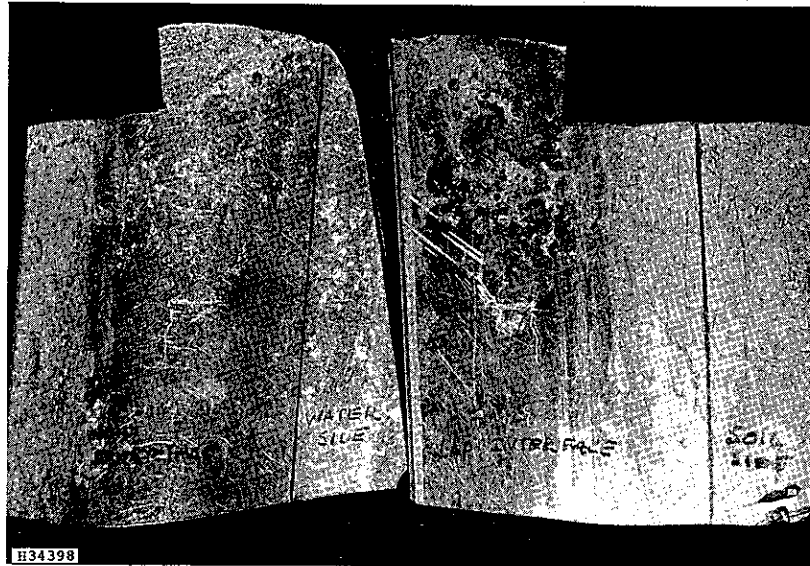
Crown Lap Interface

Water Side: No corrosion

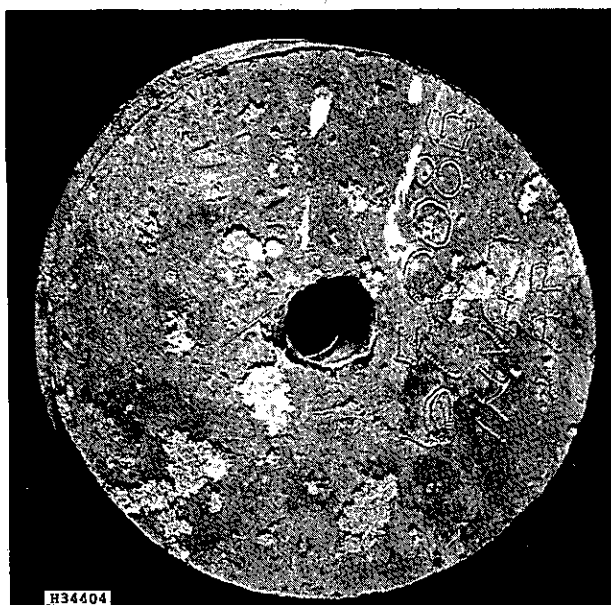
Invert-Lap  
6-Feet from East End

Water Side: Slight abrasion, mechanical  
damage and slight pitting,  
limited to cladding layer  
(depths 0.004-inches)

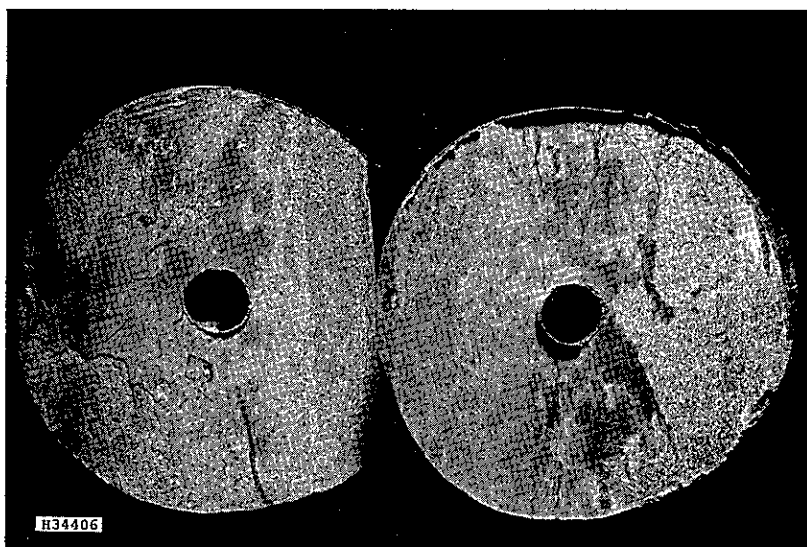
Invert Lap, Interface

N.B.--Good example of cladding effectiveness to protect core. Photo on left shows lap side attack confined to 2-mil thick cladding. Photo on right shows lap side corrosion confined to cladding layer which is 5 mils thick.

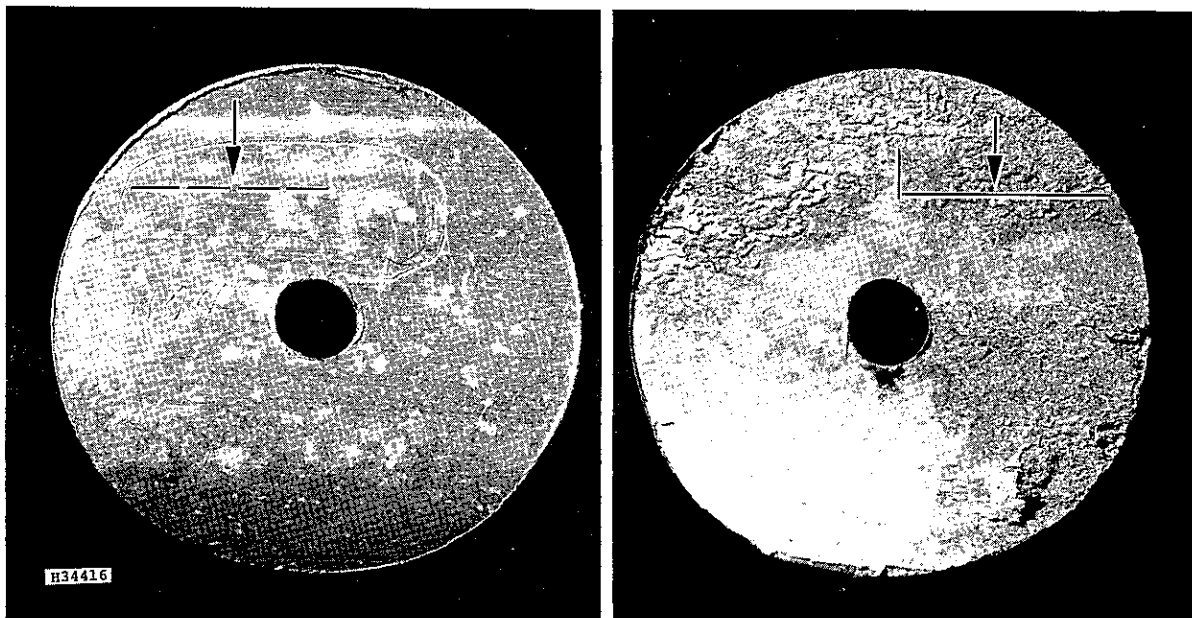
Crown Area

Soil Side: Laboratory cross-sections show a general attack of the cladding, with a metal thickness of 0.100 to 0.102 inches.

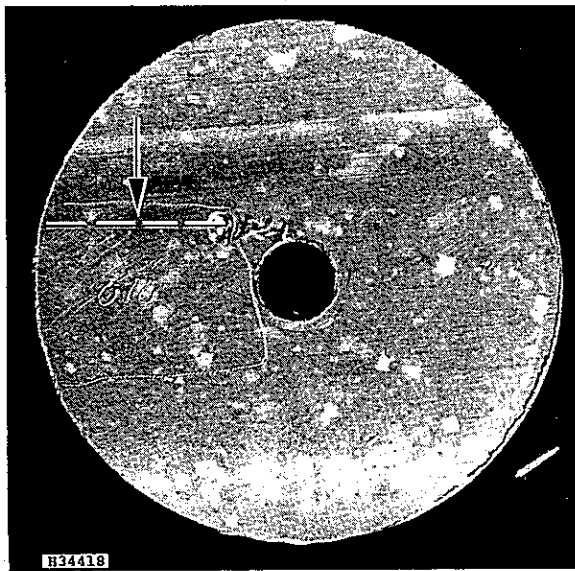
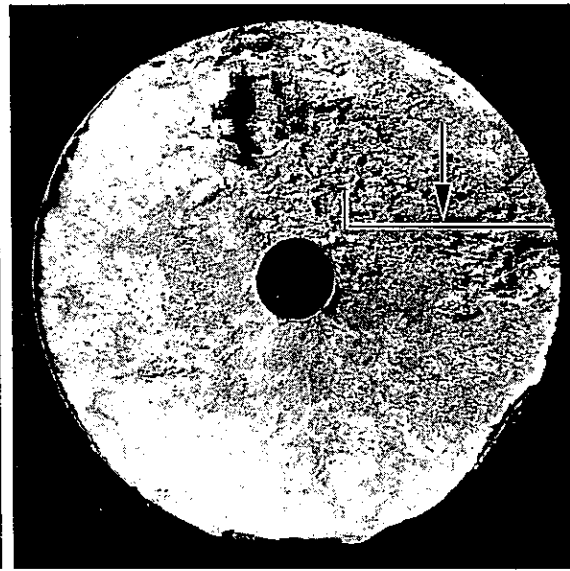
Crown Area

Soil Side: Corrosion of the cladding layer and into the core alloy was measured at 0.094-0.098 inches.

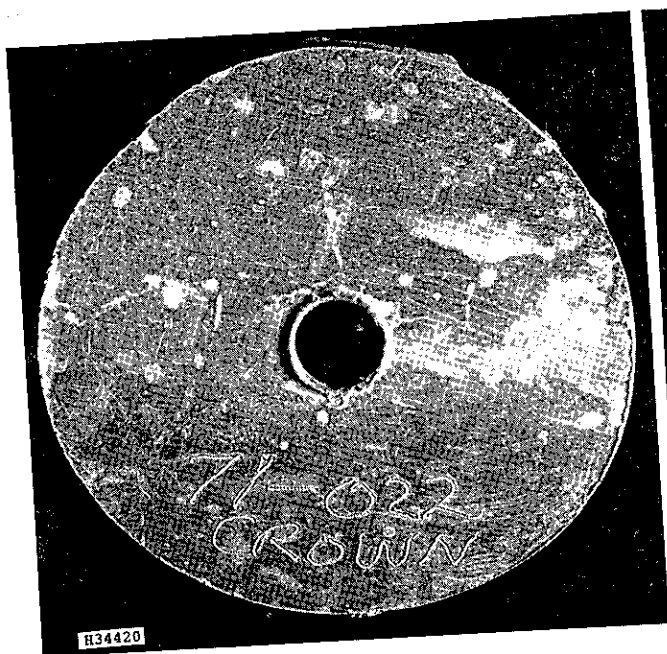
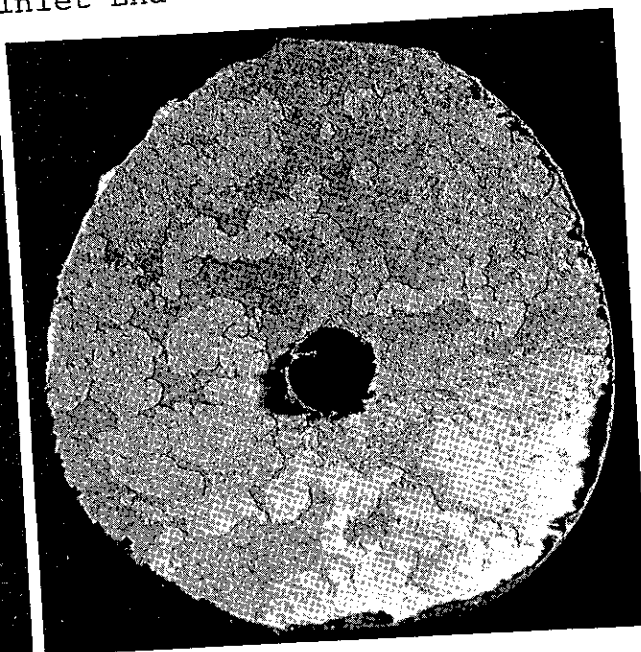
Crown  
14-Feet from Inlet End

Soil Side: Corrosion, in the area x-sectioned, reduced the metal thickness to 0.067 - 0.070 inch.

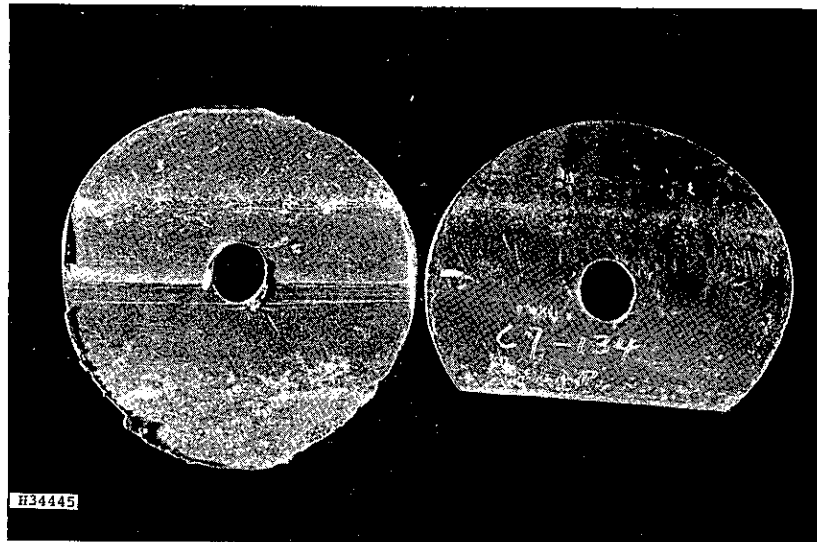
Crown - Lap Interface

Lap Interface: No attack

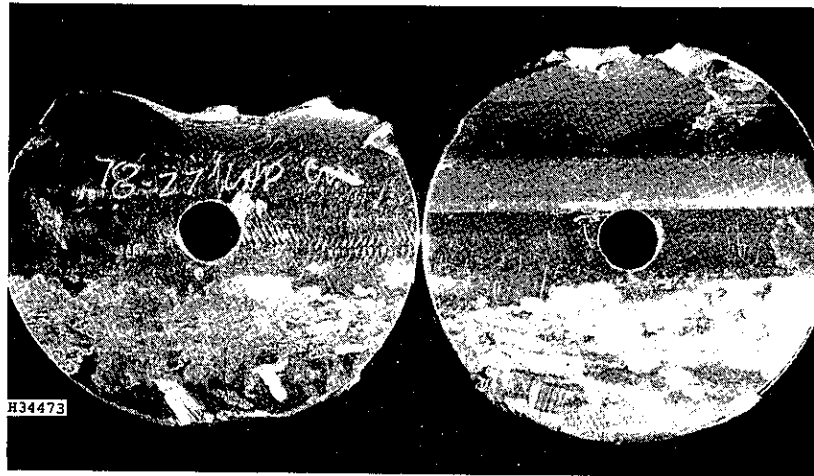
Crown Lap (Interface)

Lap Interface: Staining, no measurable attack,  
slight mechanical damage

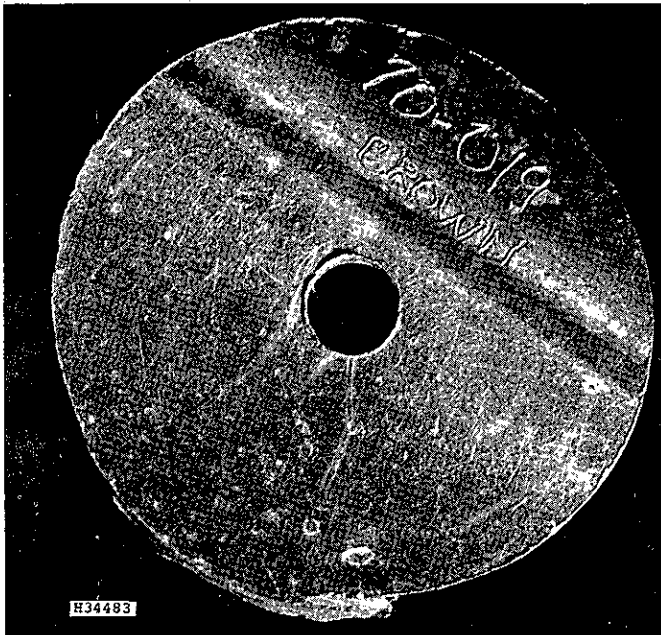
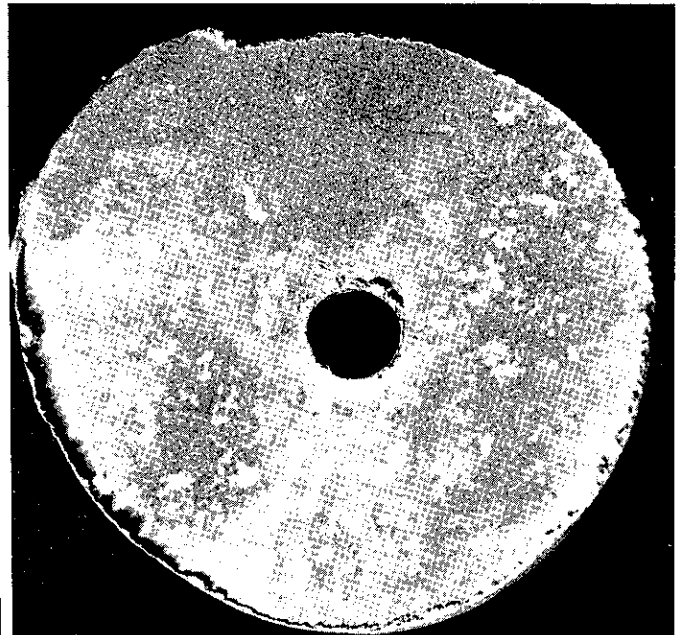
Crown  
10-Feet from Inlet End

Water Side: Attack of cladding layer,  
0.0053 inch (culvert filled  
with soil)

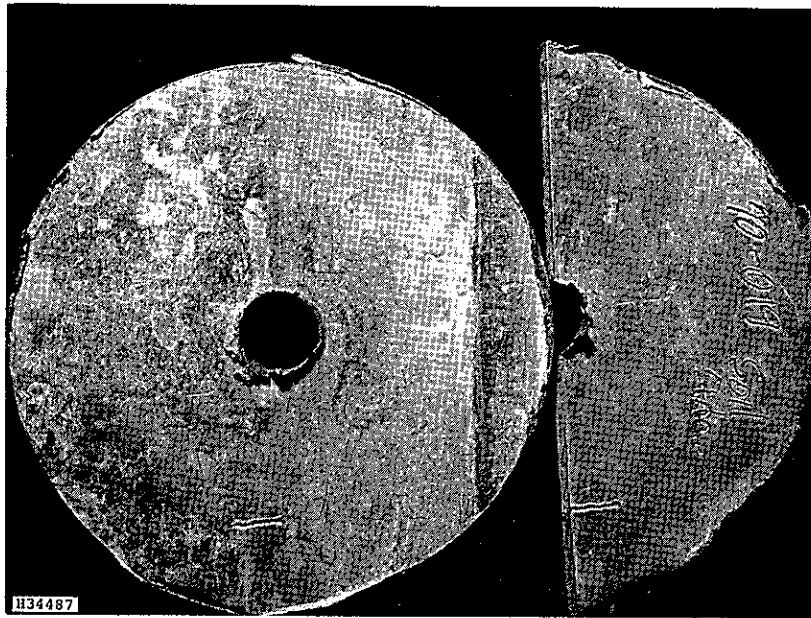
Invert Lap

Lap Interface: No measurable attack

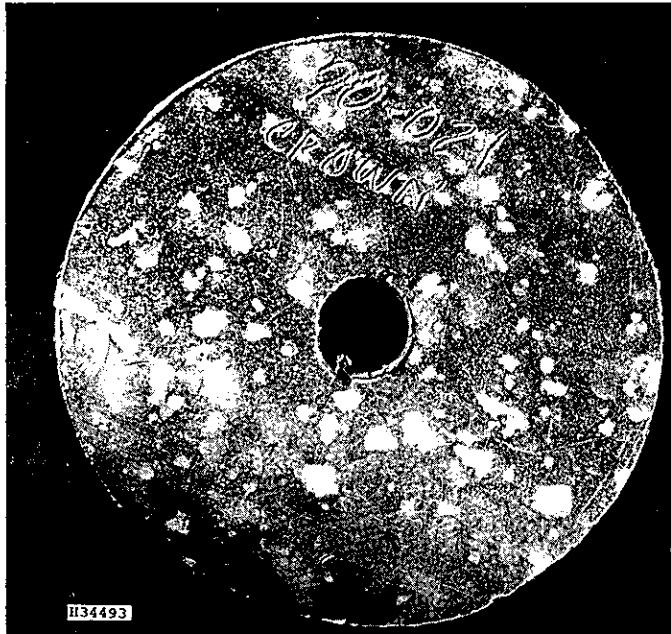
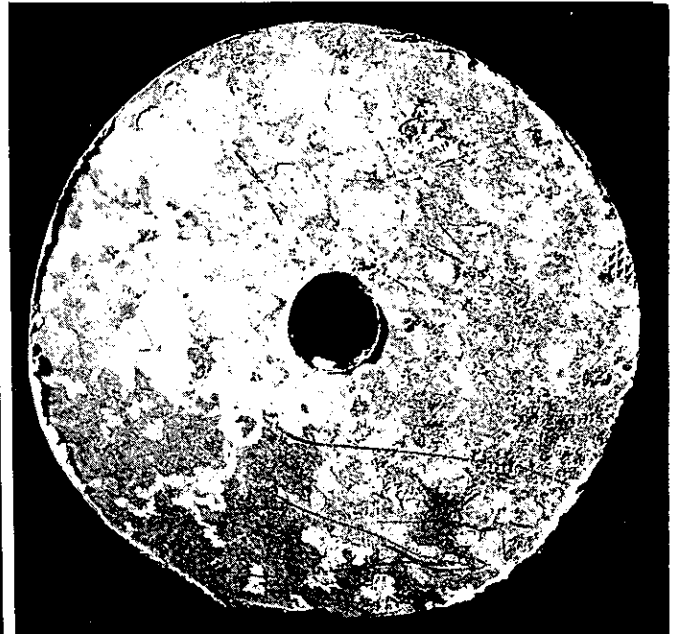
Crown  
5-Feet from Outlet End

Water Side: Attack largely confined to the  
cladding layer, maximum depth  
about 0.0080 inch

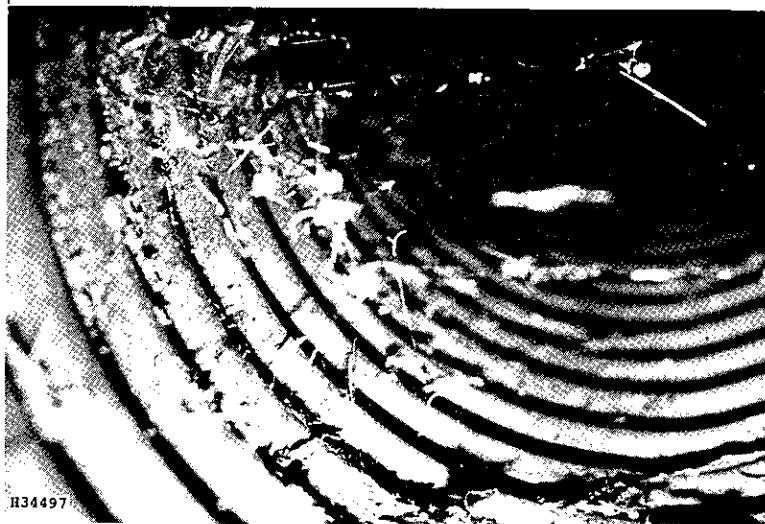
Springline & Invert

Soil side: Stain-etch attack, no measurable  
attack

Water Side: Slight abrasion limited to the  
cladding layer, 0.0025 inch
